Asking the right questions

Sevenside's Gary White explains the ironer clothing choices.

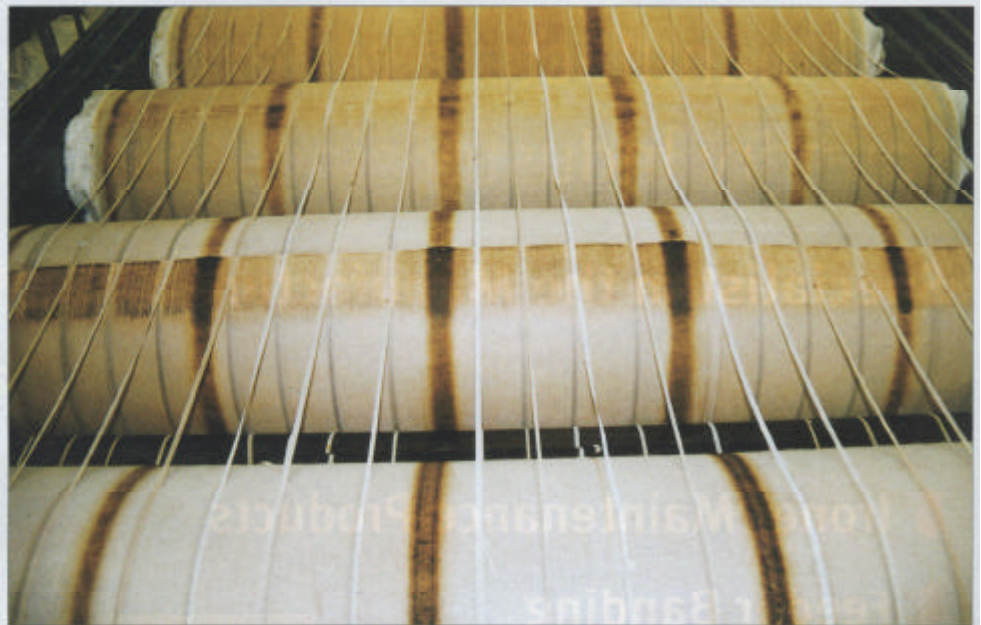
On Roller no 2 there is an 8in needlefelt overlap. The overlap creates a high spot which shows up as a dark horizontal strip.

- quality, weight, width and thickness?
- Has the steel measuring tape supplied with the ironer been used to check that the circumference of the roller (when padded) is within permitted limits?
- Is the new clothing bedded in?
- Have the overlaps been cut back four days after fitting? Failure to do so will create high spots.
- Was the calender reclothed at full steam pressure? It cannot be reclothed when cold.
- Where applicable, is the top clothing lapped into the under clothing a half turn?
- Are the clothing overhangs on either side of the roller equal?

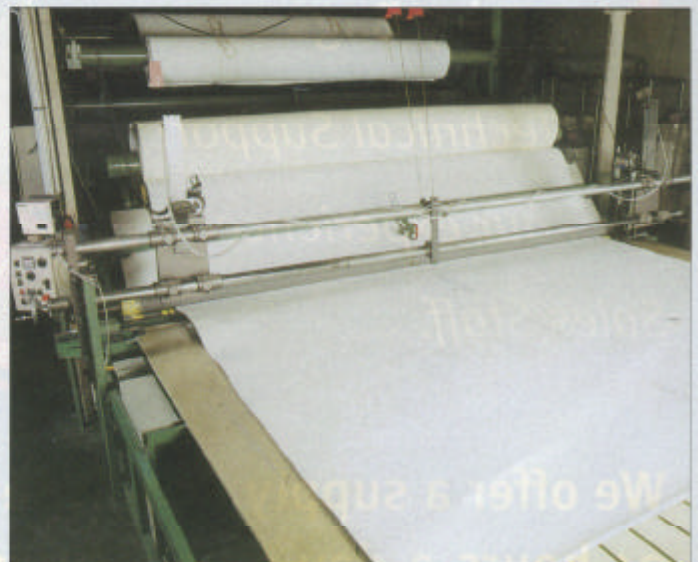
Clothing on a cutting table. Clothing must be measured and cut accurately to length and also cut on the square.
